174 Bosworth Creek (NWT)
Literature Review

Senes Consultants Limited and Glen Guthrie. 2009.
Bosworth Creek (NWT) Literature Review
Environmental Studies Research Funds Report No. 174. Yellowknife, NT. 28 p.

Bosworth Creek (NWT) Literature Review

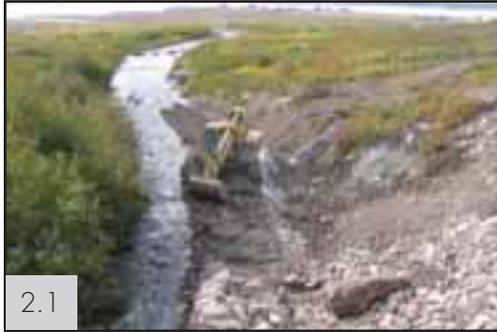
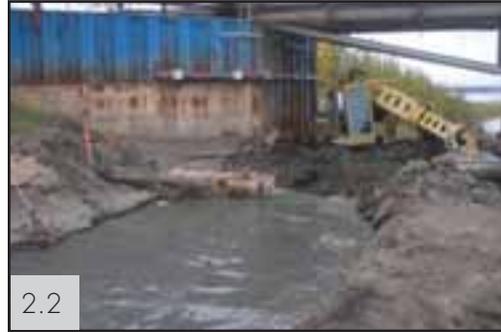
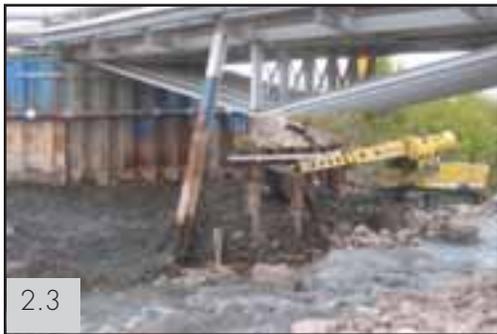
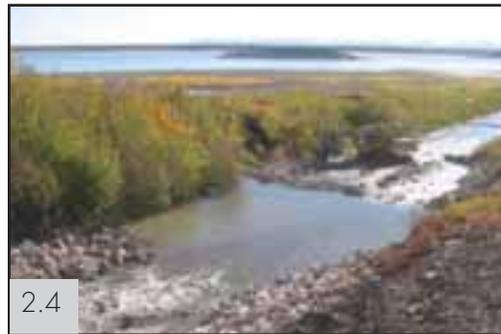
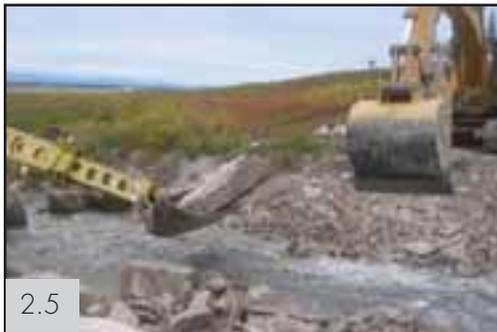
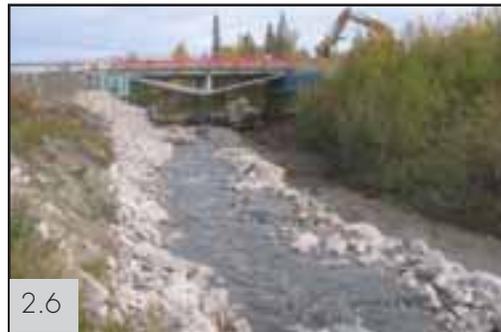
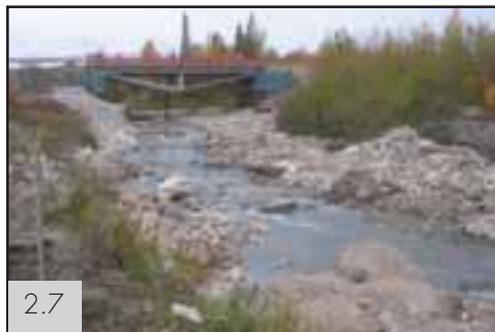
FIGURES 2-1 THROUGH 2-7
PRECISION GRADALL WORK ON BOSWORTH CREEK

Several pictures of works around the weir area on Bosworth Creek were located and are shown in Figure 2-1 through Figure 2-7 (Precision Gradall 2008). These pictures document the re-contouring of Bosworth Creek and show that efforts were made to stabilize the banks and mitigate erosion through placement of rip-rap and gravel along the shore, either during re-contouring, or as part of the weir construction and/or decommissioning. From Figures 2-6 and 2-7, it appears that during re-contouring, the creek was modified including the creation of several riffles.

Dismantling of the weir was initiated in the fall of 2004 and completed in 2005. Following removal, a project was initiated to re-contour the bed and banks of Bosworth Creek to allow fish (specifically arctic grayling) access to traditional spawning areas upstream of the lower Bosworth bridge (Imperial Oil Resources 2005). An engineering design was developed to facilitate fish movement by re-contouring the creek bed to a slope of approximately 30. This 30 grade represented a lower-angled creek-bed than the historic grade based on earlier engineering diagrams (Imperial Oil 2005). Hydraulic analysis of the rehabilitated stream was conducted to determine the capacity of the creek and the flow velocities during high flow. Flow velocity below the bridge was calculated to be on the order of 2.3 m/s. Flow velocities in the pool area ranged from approximately 2.6 to 2.8 m/s depending on proximity to rocky outcrops. Flow velocities in these areas were approximately 3.1 m/s. Further details of the water management techniques, design modifications, construction work, final survey and hydraulic analysis are given in Komex 2005. At the request of DFO, Streamworks Unlimited was asked to provide advice on the channel and bank stabilization with respect to long term fish habitat and passage (Bates 2005). There were some initial concerns such as the placement of large boulders at 5-m spacing along each bank as potential resting places for fish. It was felt that these boulders may not be adequate at higher flow conditions for fish spawning. Modifications were suggested to the earlier surface design, and included the construction of three riffles and pools along the channel which would improve stability by dissipating energy, and provide areas for fish resting and holding. The three riffles were placed approximately 30-m apart and constructed to be about 0.9-m in height, allowing each riffle to backwater the toe of the next riffle upstream.

In summary, a relatively stable bank section with good opportunities for fish passage at a range of flows was created downstream of the bridge over Bosworth Creek. Still, it remains unclear whether the channel has been monitored for fish passage successes or spawning activities (Bates 2009). A report was prepared for DFO on the weir removal which included a summary of proposed engineering activities; however, there were no biological studies proposed (Imperial Oil 2004).
