094 Dynamics of Iceberg
Grounding and Scouring

Volume 1 — The Field Experiment

REPORT NO. 094, VOLUME I

THE DYNAMICS OF ICEBERG GROUNDING
AND SCOURING (DIGS) EXPERIMENT
AND
REPETITIVE MAPPING OF THE
EASTERN CANADIAN CONTINENTAL SHELF

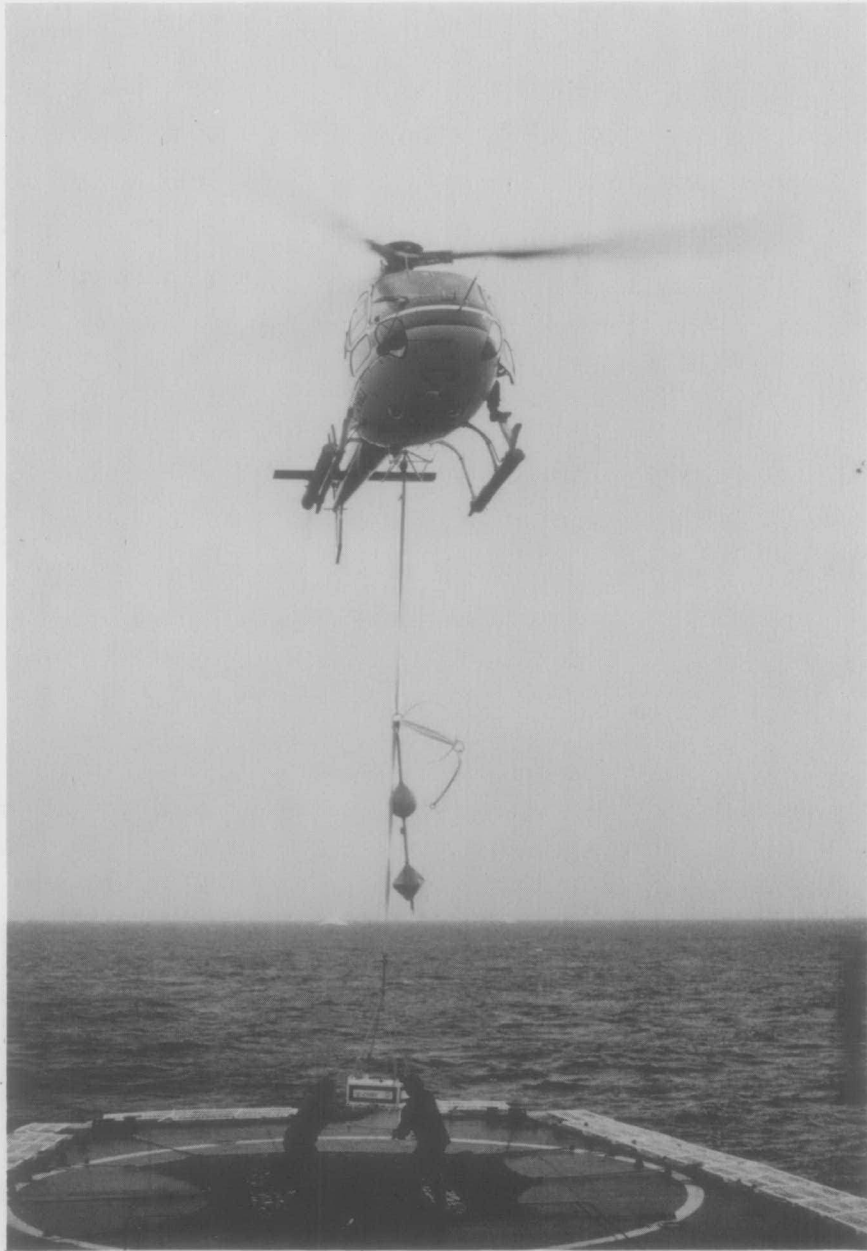
Figure 12. Helicopter lifts a C-CORE motion sensor package.

Deployment and Recovery of Packages. Five deployments and recoveries of the C-CORE motion sensor packages were achieved, over periods ranging from one to four days. In each case the package was powered up, checked and sealed, in the hold of the Polar Circle, then lifted onto the main deck. It was then connected via lanyards to the cargo hook of the helicopter (Figure 12). After careful lift-off, the package was flown to the target iceberg, and deposited on the ice in a roughly horizontal position (Figure 13). The package orientation on the iceberg was later determined from aerial photographs taken during the deployment. The packages were all retrieved by helicopter, either by employing a grappling hook or by hovering sufficiently close to enable direct lanyard hook-up.

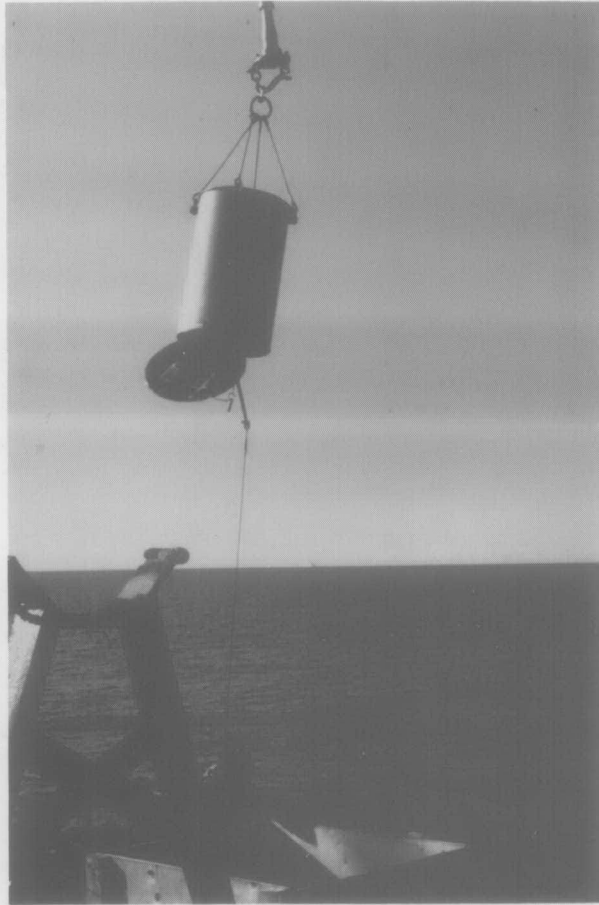
Figure 15. Deployment barrel for pollucite. The barrel is 60 cm high and 41 cm in diameter.

The sediment was deposited using a barrel deployment device (Figure 15), which was triggered to release upon contact with the seabed. At each site 20 kg of tracer sand were deployed along with an anchored buoy to act as an

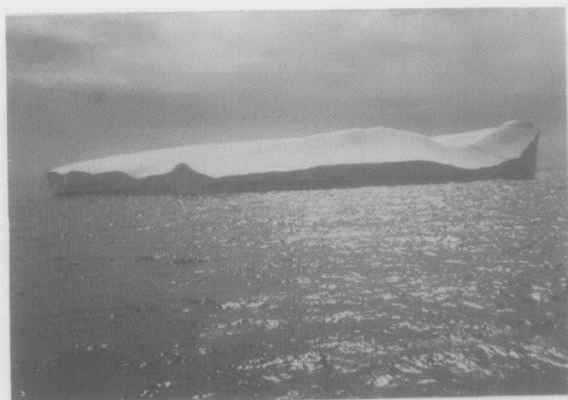
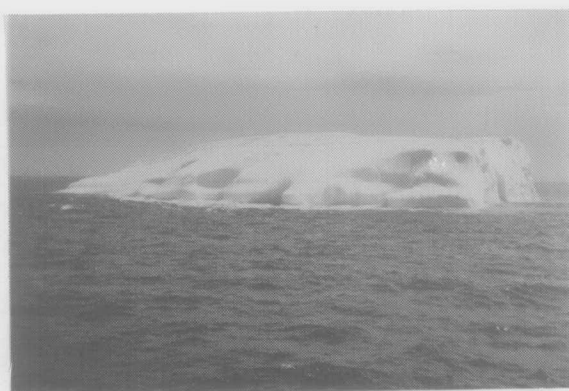
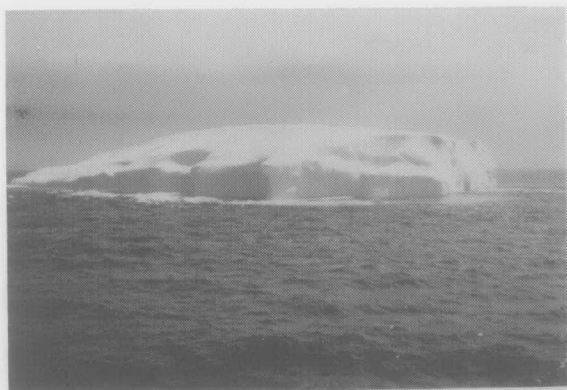
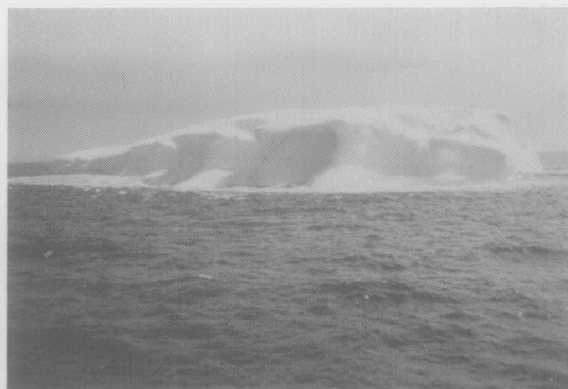
Figure 20. "Anastasia" roll sequence.

Preparations were made for C-CORE motion sensor package deployment. Before deployment and without prior warning by calving, "Anastasia" rolled, at about 1645 GMT. After this roll the iceberg was again free-floating. It first moved to the southeast, then to the northeast, as indicated on Chart 5. Numerous photographs were taken of this iceberg before, during, (Figure 20) and after its roll. In addition, the roll was recorded on videotape which is archived at AGC.

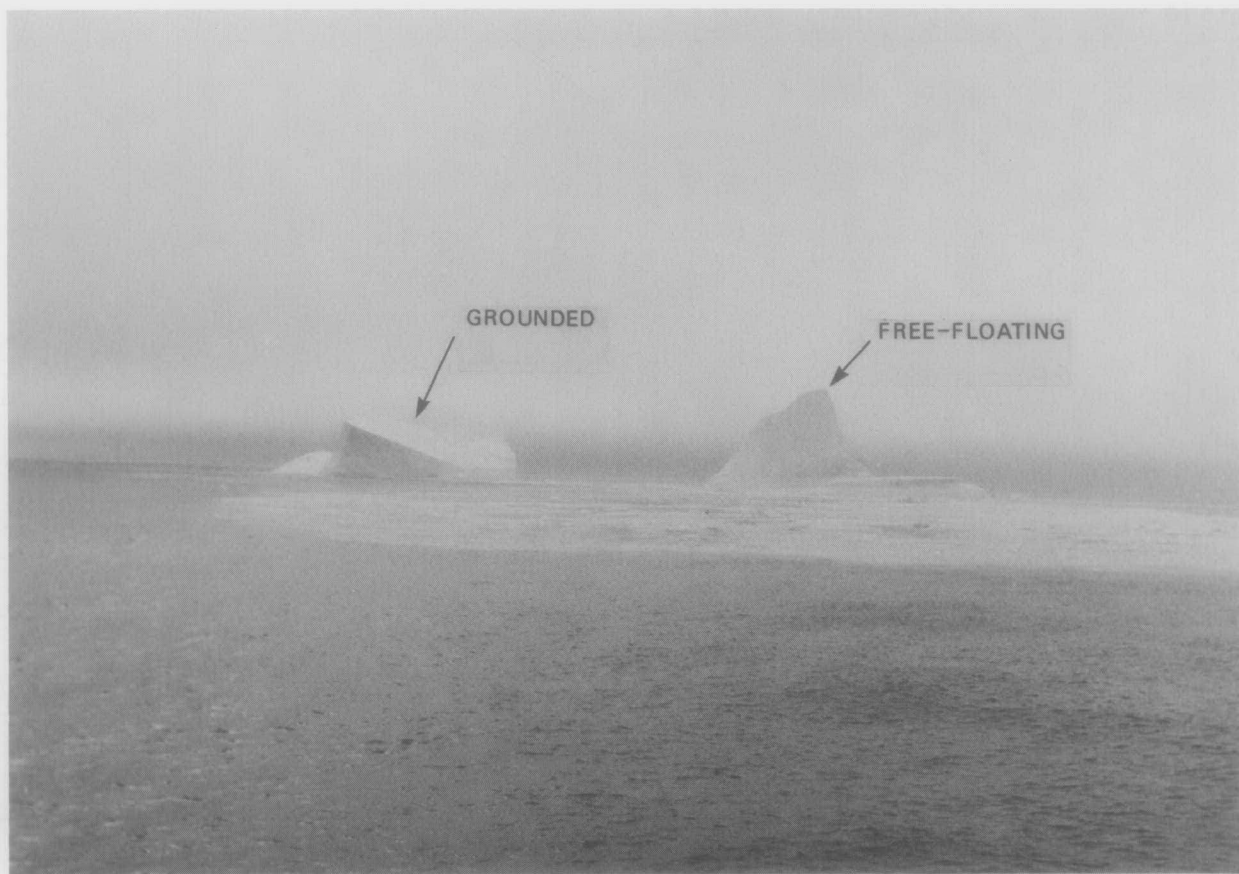
Figure 33. The two major pieces of iceberg "Gladys" after the split on August 10.

Ship and aerial photographs of the portion of "Gladys" that remained free-floating after the split on August 10 are shown in Figures 33 and 34, respectively. No photogrammetric analysis was performed on these stereo images because this portion of "Gladys" did not scour the seabed.

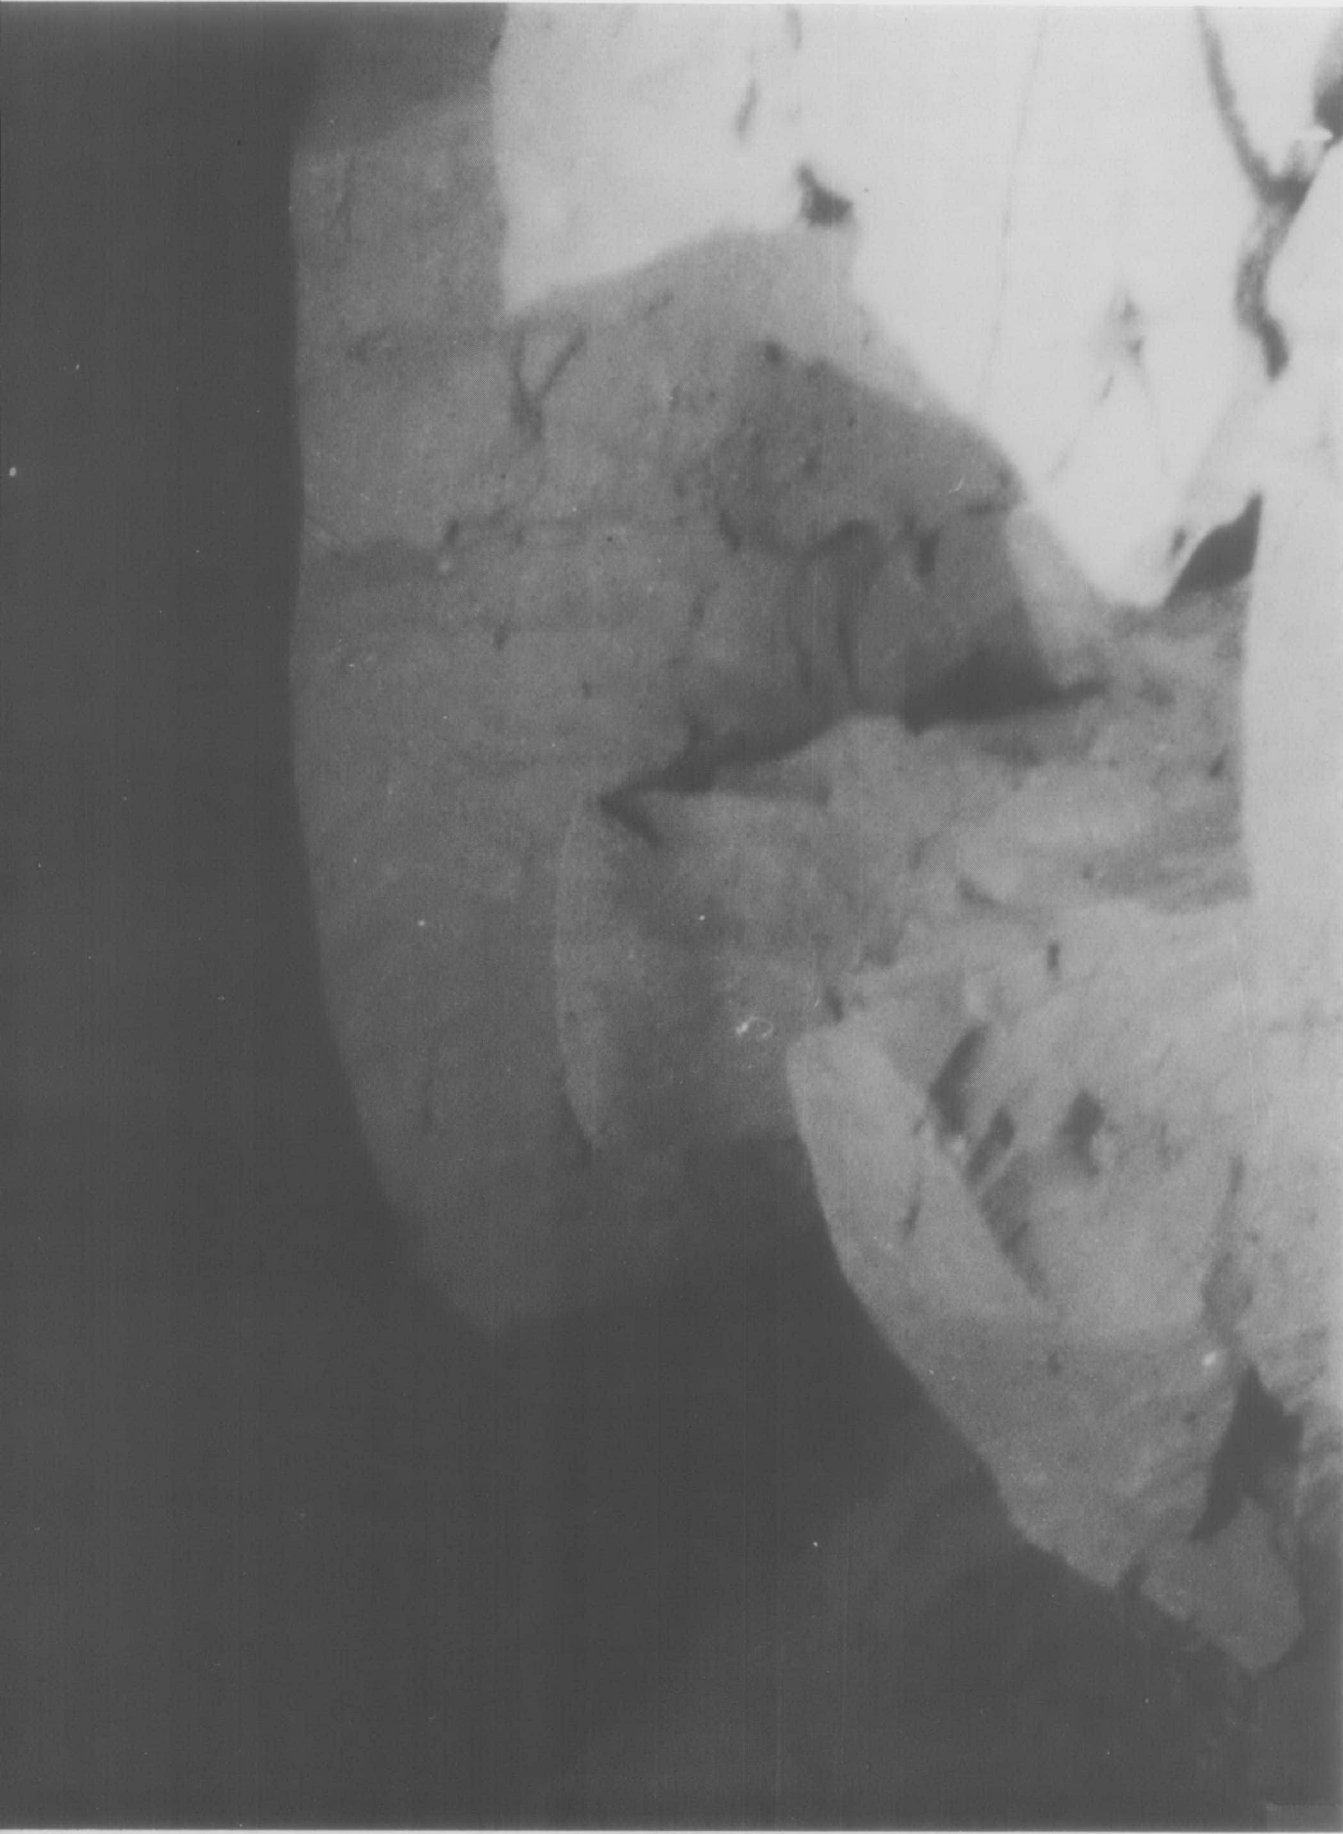
Figure 104a. Massive blocks (1-2 m high) from the berm of the new scour at the "Caroline" site display crude vertical fracture patterns.

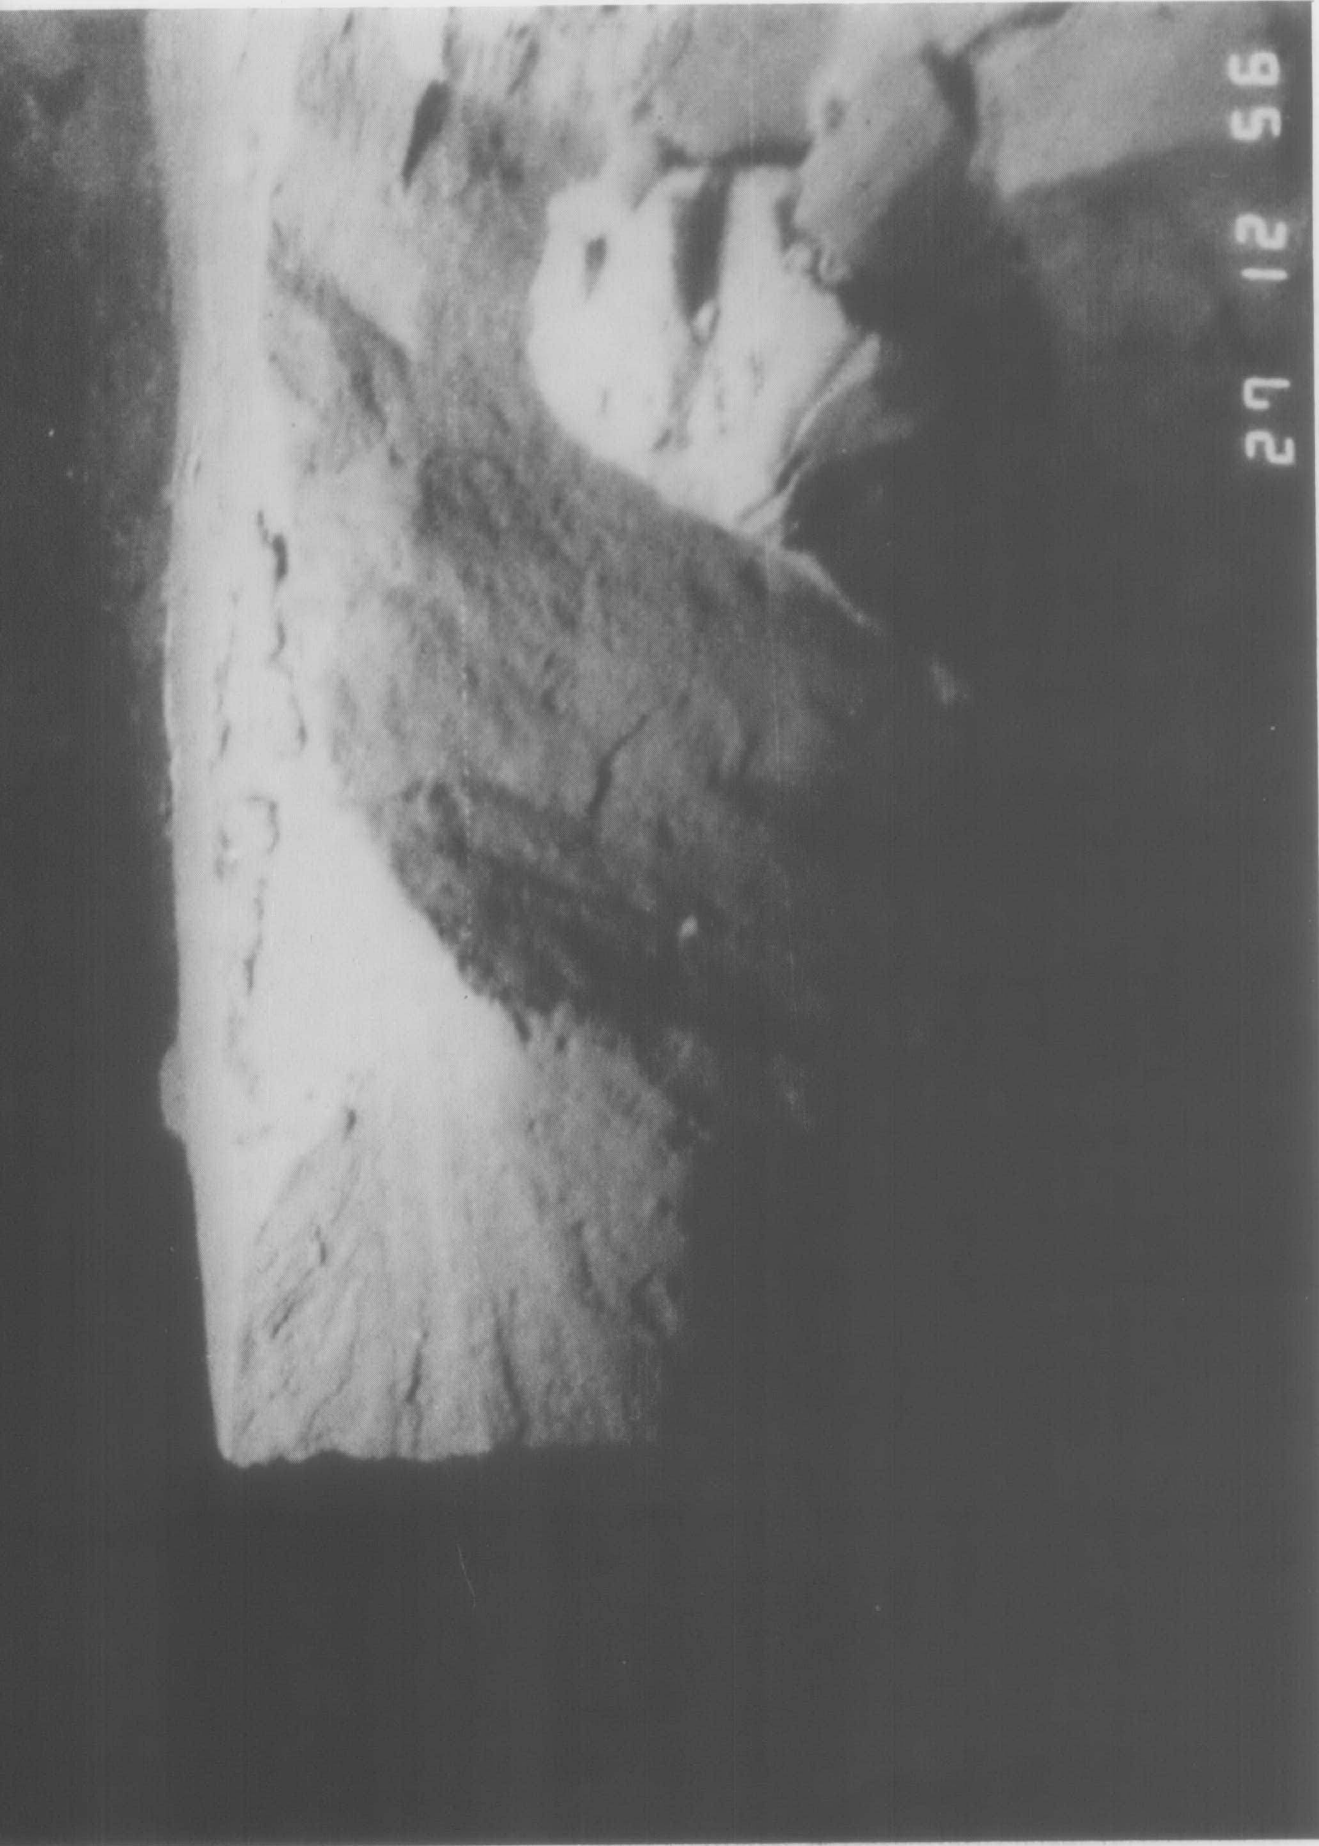
Figure 104b. Vertical face of a block (1 m across) showing a radial fracture pattern, also from the new scour at the "Caroline" site.

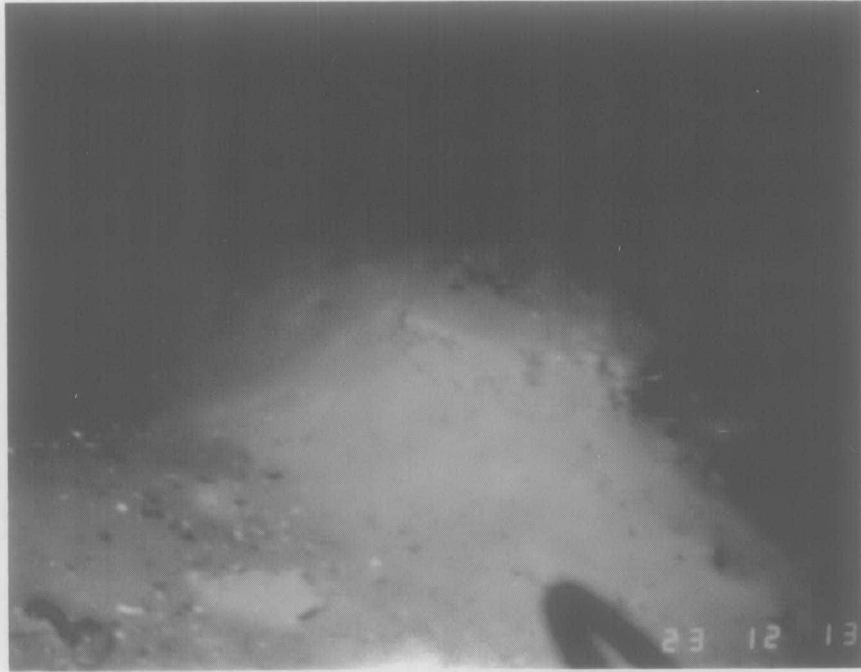
Figure 106. Sample of a flat-topped mound, about 0.5 m high, resting above apparently undisturbed seabed in a linear depressed area within the scour of "Big Makk".

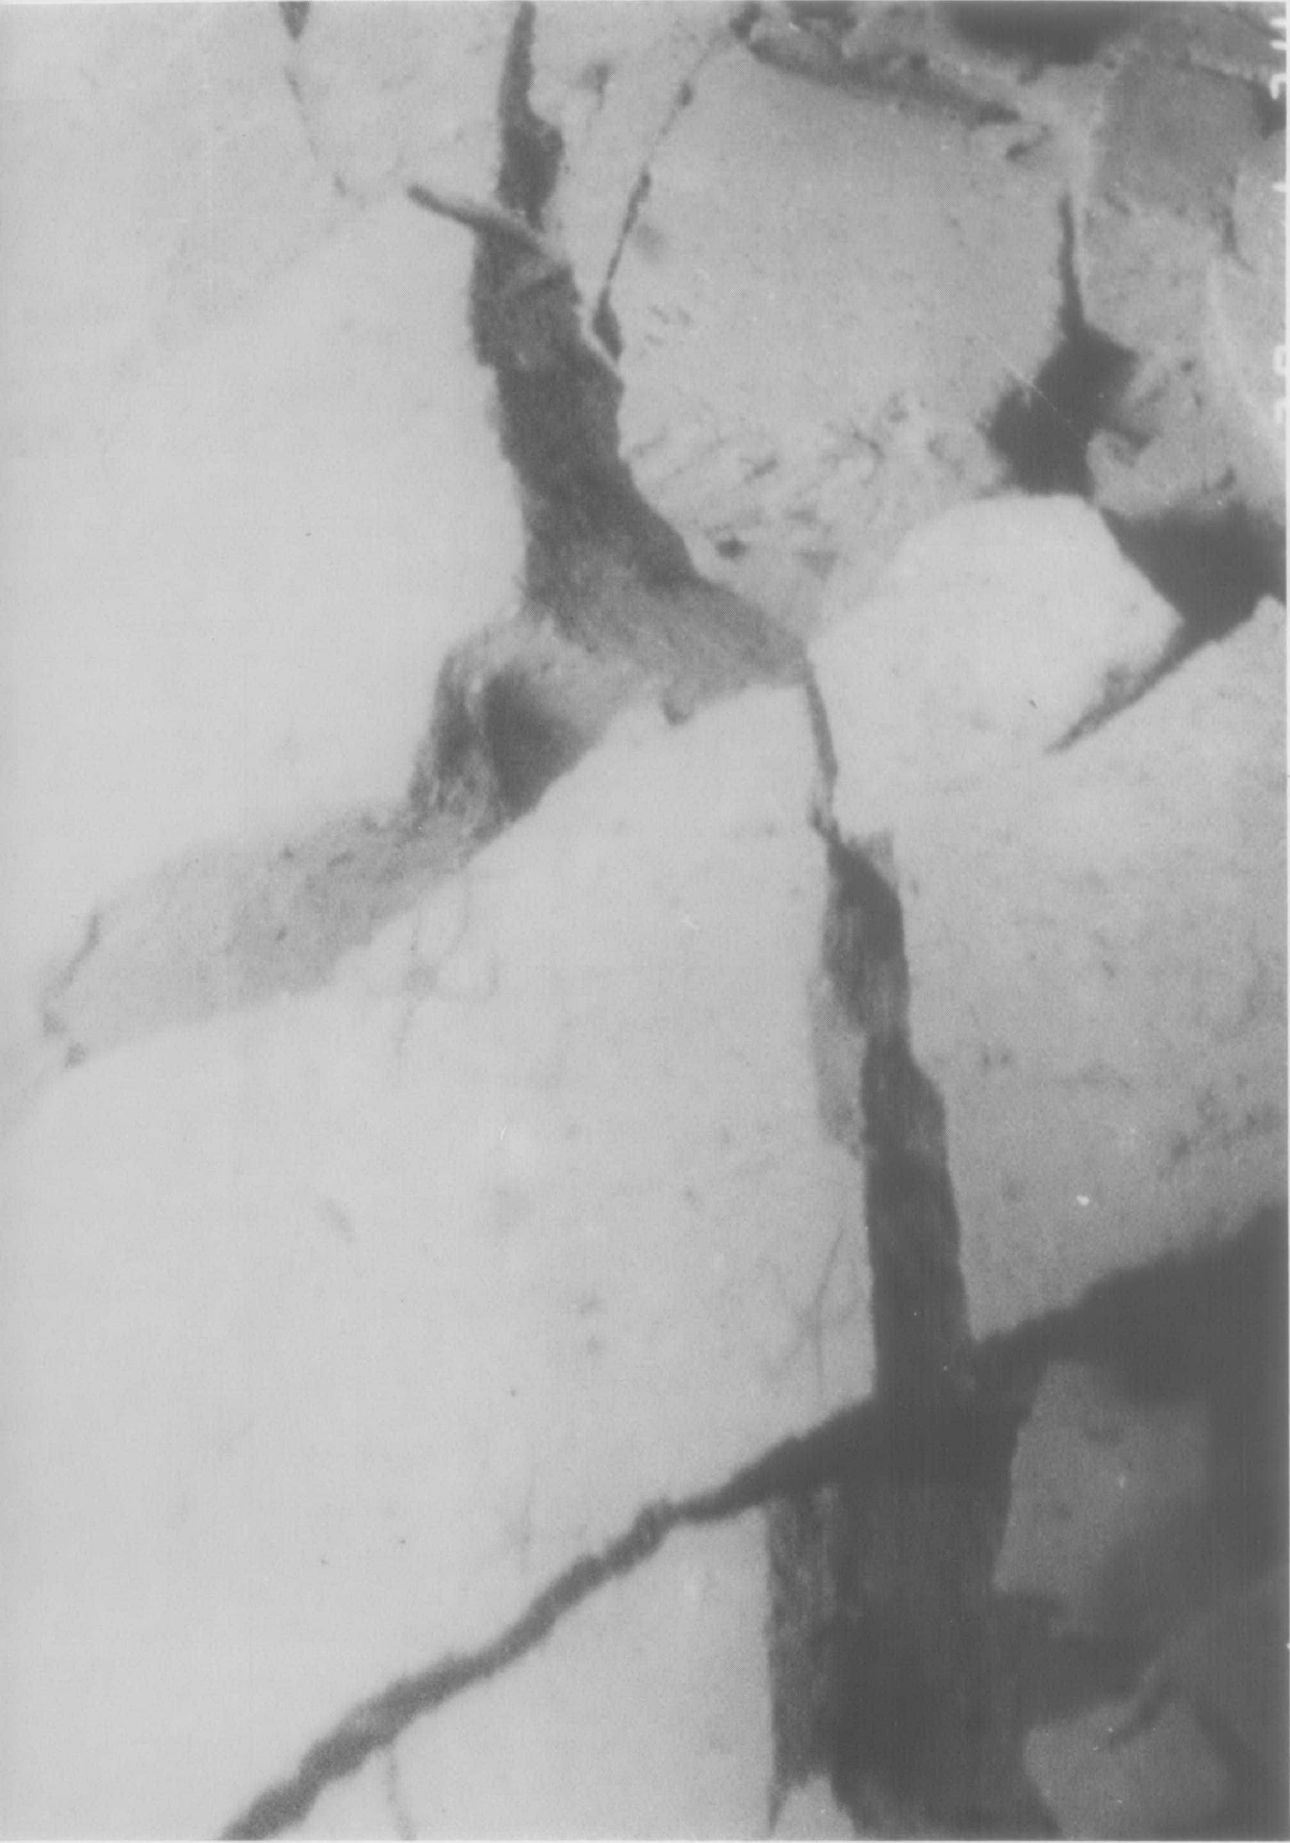
Figure 107. View of blocks fractured in situ on the inside berm flank of the new scour at the "Caroline" site. Field of view is approximately 3 m across.

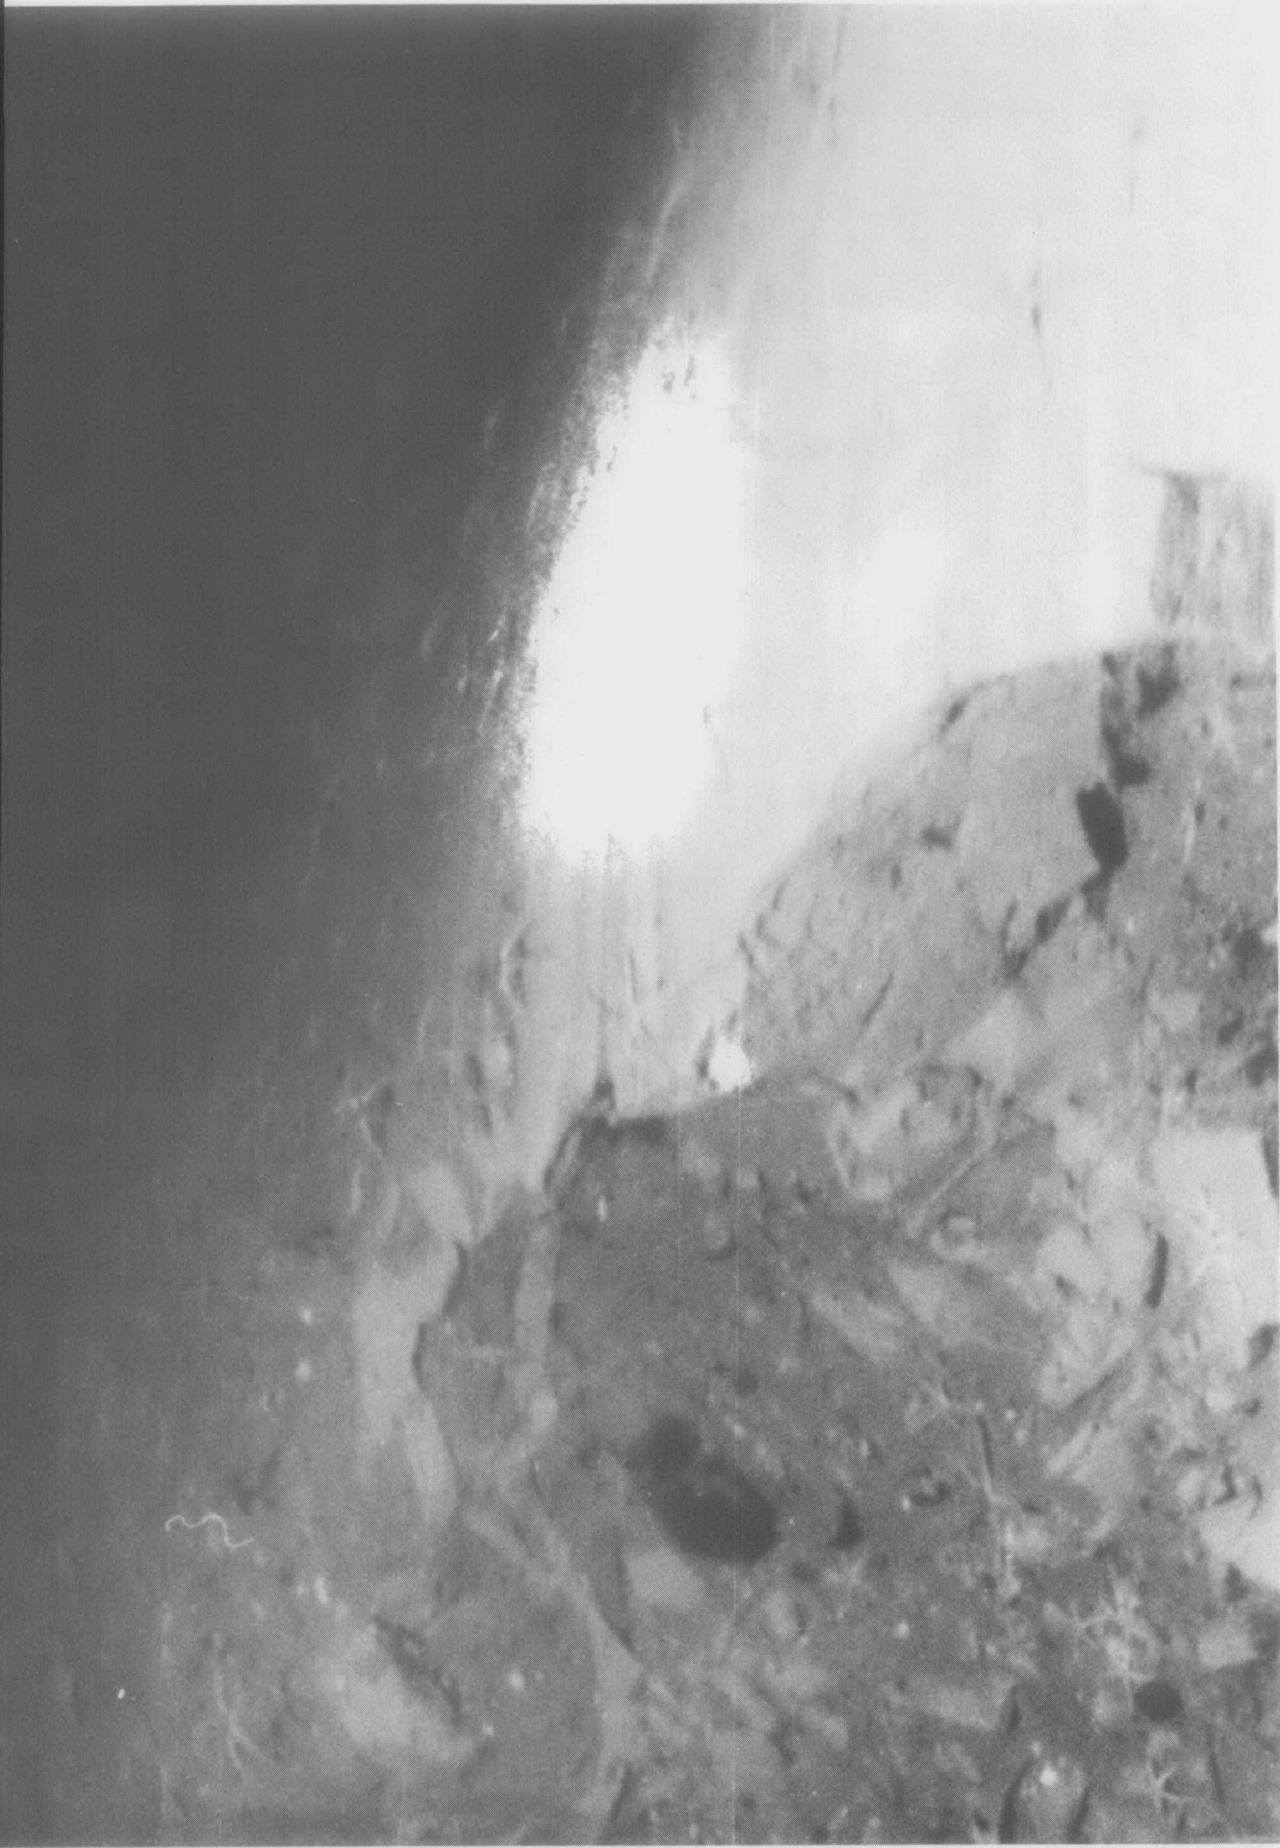
Figure 108.

View of the abrupt transition from consolidated material of the inside berm flanks on the right (note the small-scale ridged and grooved surface), to disaggregated, largely unconsolidated sediments of the outside berm flanks on the left from the "Caroline" site. Field of view is approximately 3 m across.

The berm crest marks a transition from relatively intact, in-situ blocky sediment, to smaller, disaggregated and chaotically arranged blocks which characterize the outer berm flanks (Figure 108). Some of the material constituting the outer berm flanks is derived from fractured sediment blocks which have spalled from the berm crest probably both during and after the scouring event. This process generates a characteristically disaggregated, rubbly outer berm slope. The smaller blocks and pieces commonly rest in a fine-grained matrix which is probably in part derived from disaggregation of originally larger blocks at the berm crest during mass wasting and by later bioturbation and current winnowing.
